A Forensic HF/E Analysis of a Trip and Fall Injury Event Involving a Wheel Stop in a Parking Lot

M. S. Wogalter^(✉)

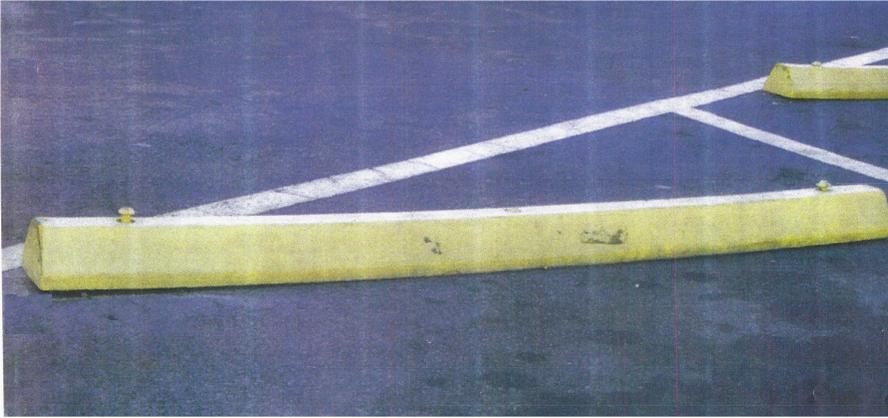
Photos after Mary’s fall confirmed the attributes that Mary mentioned. The wheel stop (also known as a bumper stop, parking stop, tire bumper and other names) was warped and the bolt (sometimes called a lag bolt or rebar spike) was partly sticking out above the parking stop.

According to an engineering report produce by an expert retained in the resulting legal case, the subject wheel stop was composed of recycled plastic and opined that this material reacts to a greater extent to temperature changes than wheel stops traditionally composed of concrete. Wheel stops with recycled materials can result in substantial temperature-based distortion. With heat during the summer months it can expand and warp. These wheel stops may never completely return to the original horizontal shape when they contract in colder temperatures. Without this technical knowledge, the use of wheel stops made of recycled products would seem to be environmentally beneficial, i.e., doing the “green” thing by reducing landfill use. It was never determined in this case’s discovery phase whether recycled-plastic wheel stops can be made (differently formulated) to limit warping and distortion. There is an additional relevant effect of the expansion and contraction cycles. When the wheel stop expands it causes the ends to rise up from the pavement due to being held and limited by the bolts. This has the effect of applying pressure on the bolts’ heads and moving the bolts upwards. When the wheel stop contracts in cold temperatures, the bolts at each ends of the wheel stop may remain in a raised position. As a result, it sticks out above a flatter, contracted wheel stop. People navigating across the parking lot would have to notice that the bolts are

Fig. 1. Warped wheel stop with bolt raised above its surface.

With a bowed wheel stop, a higher rise in the step is needed to go over it. An alternative is to step aside to avoid it. Warpage of the two ends of the wheel stop is not the full story about potential for height misapprehension. Several inches away from the ends of the subject wheel stop are large metal bolts intended to attach and retain the wheel stop on the parking lot surface. In the subject parking lot, many of the wheel stops, including the subject one, had bolt heads raised above the top surface. As described earlier, apparently the bolts were pulled up by the warping ends of the wheel stops and reached their apex in the hottest temperatures with the greatest expansion of the wheel stop's size. With cooler temperatures the wheel stop contracts in size and tends to straighten back out and down (but often not returning to their original state). However, with the contraction in cooler temperatures, the bolts do not return to their original position. The bolts do not come back down (or at least not all of the way) often staying in their apex position, protruding higher than the wheel stops themselves. Clearly, the bolt heads should never be higher than the wheel stop. It is a hazard when positioned over and above the wheel stop. People might not see them when stepping over the wheel stop and the bolt could "catch" the foot, shoe, or pant leg causing a misstep, a trip event, and potentially a serious fall.

A highly effective method of hazard control to prevent tripping from wheel stops is to not use them, i.e., eliminate them. If wheel stops are used, they should be made so they do no warp or change shape with expected temperature variations. There might be a way to make wheel stops with recycled material that does not warp, but if it cannot be done, then different material that does not warp such as conventional concrete should be used. Another set of design issues concerns the bolts and the associated holes. The wheel stop's bolt holes should have had a larger cylinder space for the bolt neck and a large inset space to bury the bolt head deeper into the wheel stop so that it stays below the surface. With heat and expansion, the bolt would not be pulled up, because with a wider hole, so that any expansion of the wheel stop would not move the bolt out of position, and any change in the wheel stop by expansion and contraction would slide by the bolt. A large inset space would allow some movement of the bolt without it having an apex height above the surface of the wheel stop. A deeper inset space would allow a bolt head to lie fully (and remain) below the surface of the wheel stop. At the original installation the rounded bolt head was too large to fit in a small inset space that was present, leaving part of the bolt head above wheel stop's top surface. This was an incorrect combination of wheel stop and bolt head type. The bolt head should always be below (or at least flush with) the top surface of the wheel stop.

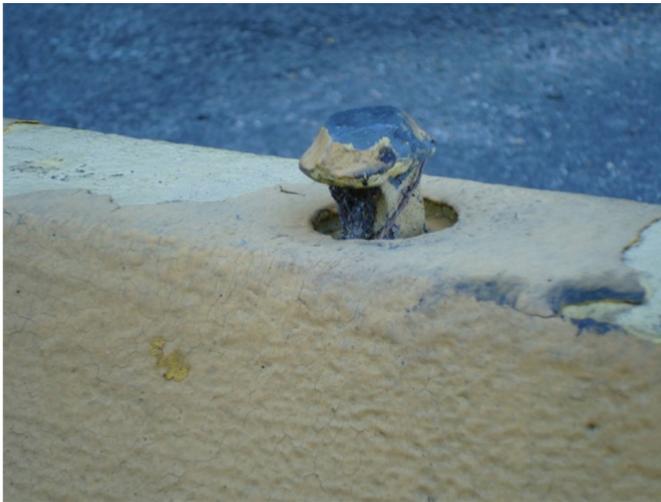
Fig. 2. Close-up of a bolt sticking out.

Fractions of inches can be the difference between successful navigation or the catching of the foot in motion and causing a trip event. The Americans with Disabilities Act (ADA) of 1990 defines a "trip hazard" as any vertical change over 1/4 in. or more at any joint or crack. Protrusions of one-eighth inch can cause a misstep (e.g., Cohen and Pauls 2006). It can catch the foot, shoes, etc. and cause a tripping event. In most localities, there are no specific regulations or laws controlling the design and placement of wheel stops in parking lots. However, human factors/ergonomics (HF/E) principles can be applied to this domain. HF/E research and principles can be applied to predict and explain safety problems in built external environments such as parking lots. Perturbations on surfaces in built environments where the public traverse is a necessary concern for property owners and management. So in order to avoid a trip and fall incident and the serious injury that might result, small, less-prominent perturbations on the surfaces in which pedestrians traverse should be a concern and should be dealt with. Bolts sticking above the surface of wheel stops are a hazard that should be controlled. It should be removed, guarded by barrier, or at least, warned about.

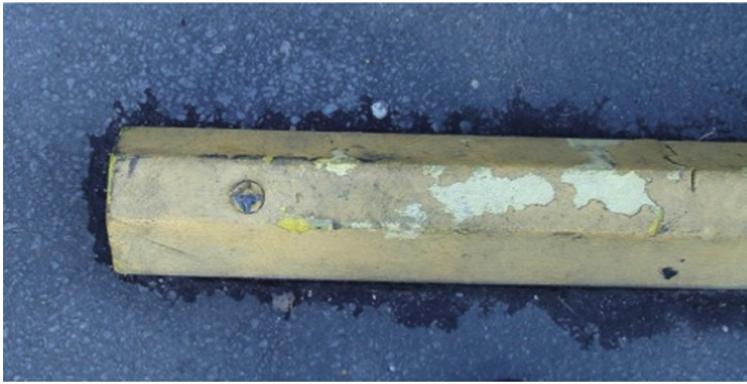
Fig. 3. Wheel stop and bolt area viewed from above.

At some point after the Mary's trip and fall, some of the wheel stops had been repainted the same bright yellow color. Some of the bolts heads and neck were coated with yellow paint (although not all of them). It is unclear whether the subject bolt was painted at the time of Mrs. Lumen's fall. Neither of the Lumens' remembered, and neither the accident report nor the police's notes mention the bolt's coloration. No photographs were taken immediately after the incident of the parking lot or the particular wheel stop. The lack of anyone noting the bolts having yellow paint on them at the time of the event suggests that the wheel stop bolt may not have been painted or incompletely covered in paint at the time of the fall. The bolt being painted *or not* could contribute to the fall. If it was painted, then under certain viewing angles it might not be seen because it was the same color of the wheel stop, i.e., there is a lack of figure-ground color contrast with the wheel stop. If the subject bolt was unpainted or mostly

unpainted, and thus mostly a dark gray color, then it could blend in with the surrounding dark gray asphalt. Viewing angles could make it very difficult to see the bolts. The raised bolt in Fig. 3 is not visually prominent.
